# Cumbernauld Town Centre

**LISTING ASSESSMENT REPORT, AUGUST 2022**

On behalf of Hamcap (Cumbernauld) LLP

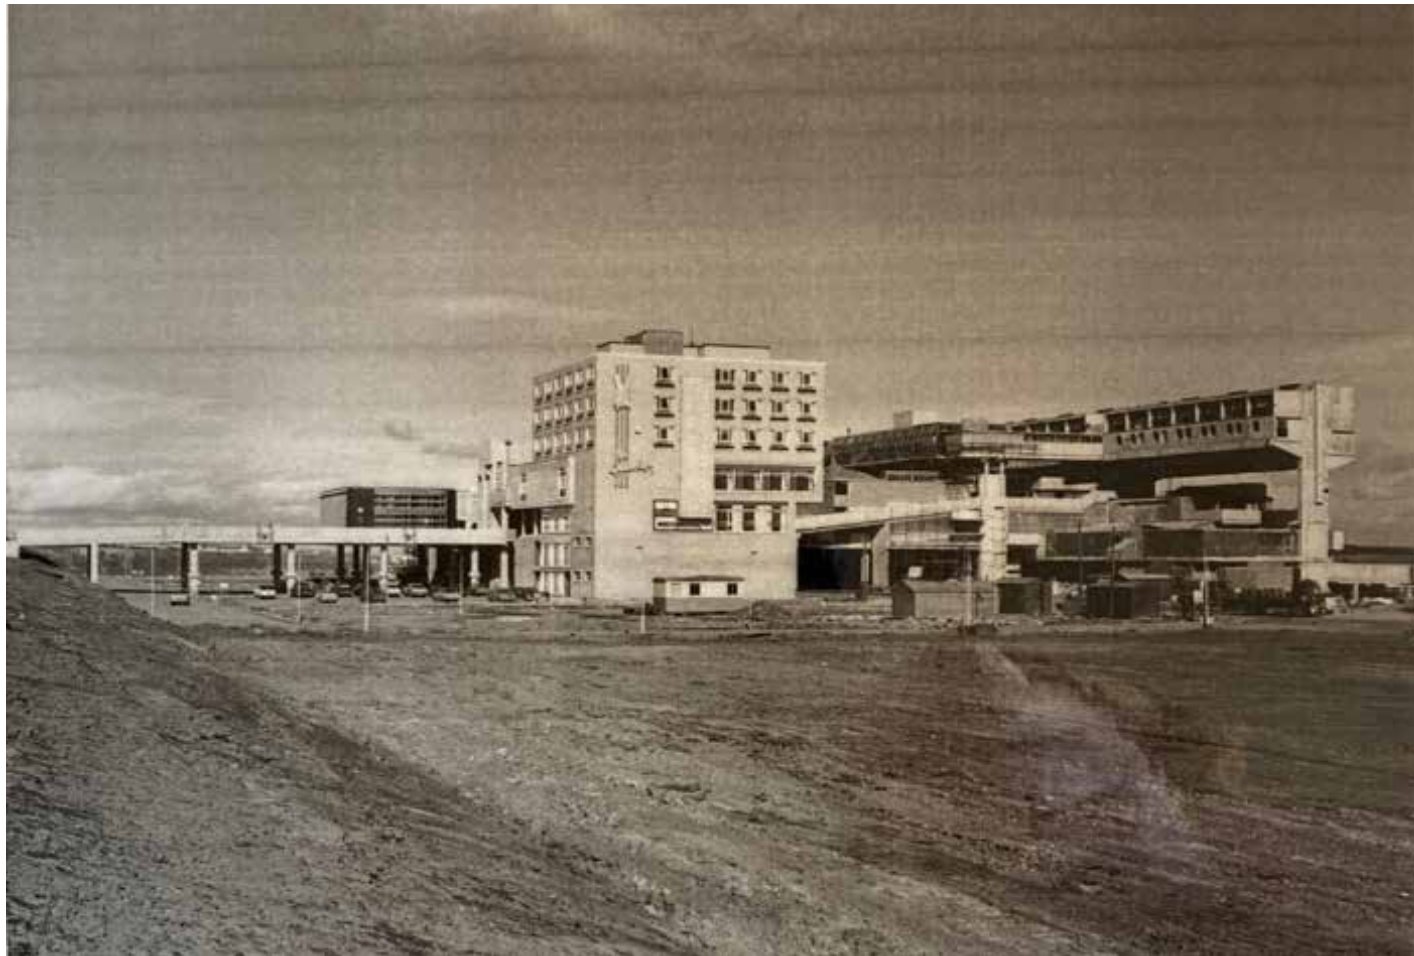
Figure 4.10 Completed Phase 1, 1967 showing the Eagle Hotel and Avon House. Note the original roofline and window arrangement on Avon House. NLC Archive.

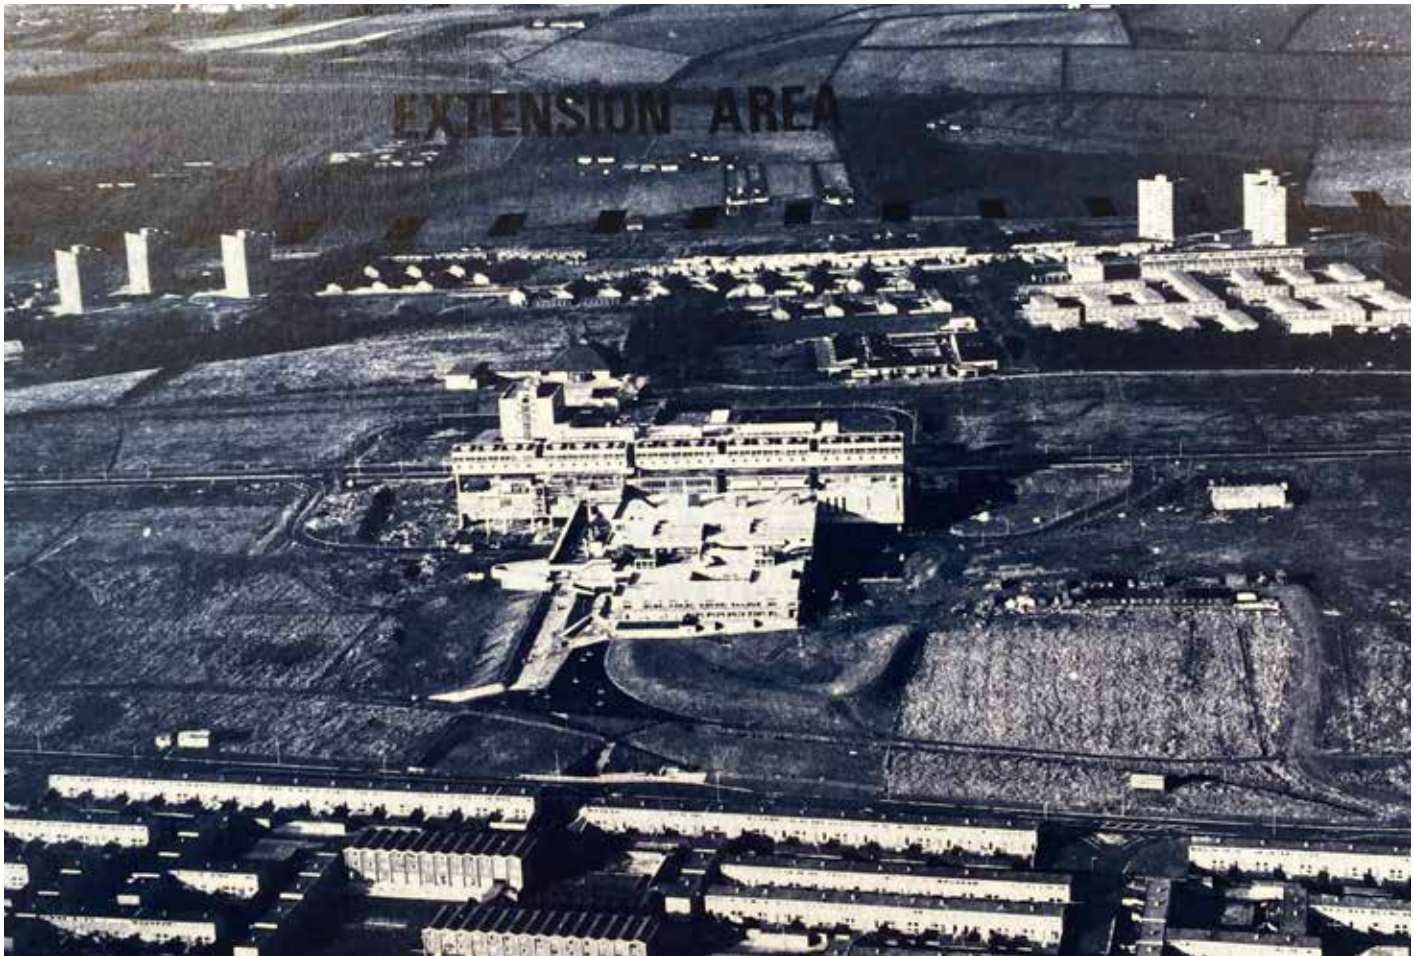
Figure 4.13 Aerial photo of the completed Phase 1 taken from the south of the Site looking north. The future housing area is marked on the image.

- 4.13 The image above is particularly important in demonstrating the significant amount of change this area of the Town Centre underwent. The ramps which functioned as the original entrance are no longer there, as well as the buildings in the foreground. All of which were later demolished for Phase 5 and the Antonine Centre.
- 4.14 The original design intention of Avon House can be seen in this image with the original roof line and window details, which were altered in 1984. The 'GAL' text is from Galbraiths supermarket (the largest in Scotland at the time).
- 4.15 The carved sculpture on the pedestal was created to mark the opening of Phase 1 and to commemorate Princess Margaret's visit in 1968.
- 4.16 The stone carving at the top of the structure came

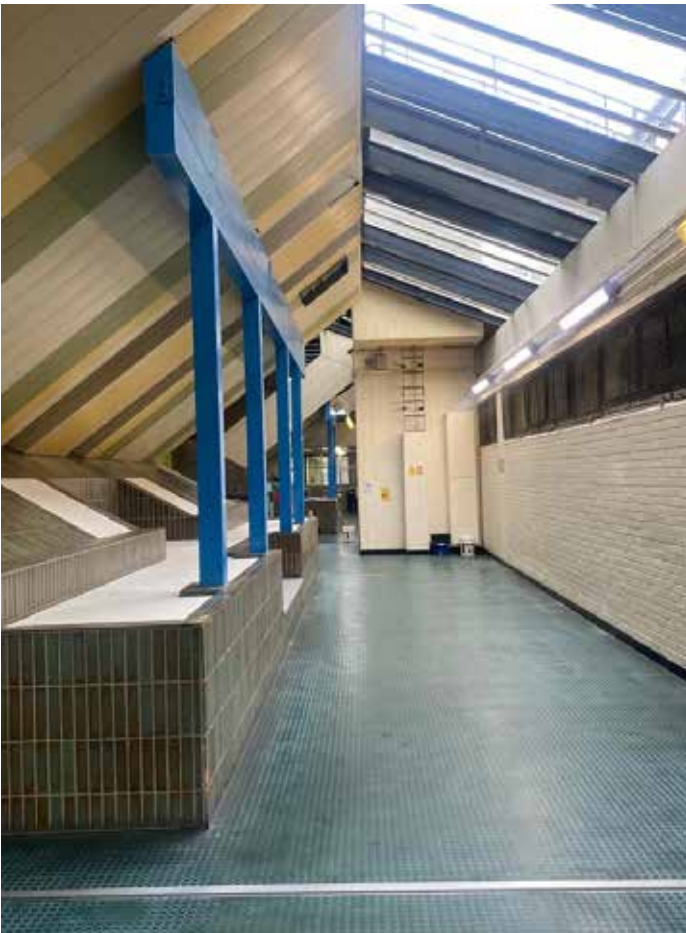
Figure 4.36 Allander Walk 2022 showing fire safety alterations with the blocking off of lower walkways

After commencement of the design sketches and discussions with the Fire Master it became evident that the existing roof patios were not suitable as a means of escape, due mainly to the fact that the roof was of timber construction..it was decided to ignore the roof as a means of escape, which allowed a very simple roof design to be considered. The new roof will give complete coverage of all the existing problem areas. In effect a metal ‘lid’ will cover the new units.

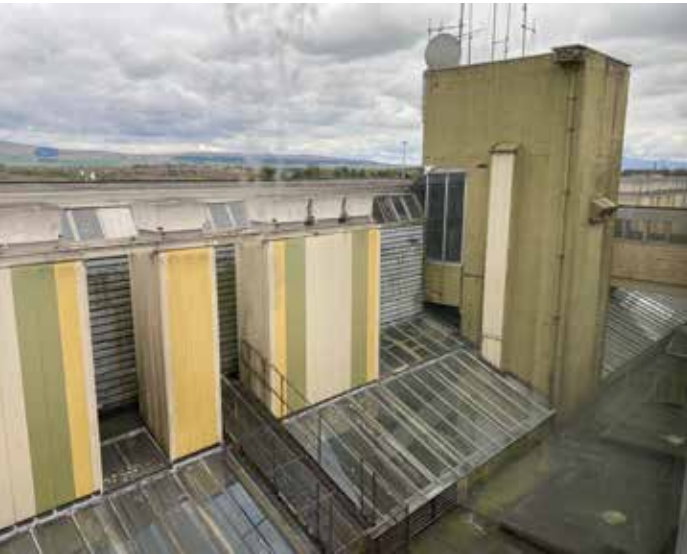
Figure 4.39 Roof exterior above Allander Walk showing covered over section of the original Phase 1 building

- 4.81 The images on the following page highlight the significant amount of alteration that has taken place, in particular at Phases 1 and 2 with extensive enclosure, cladding and encasing or open decks, walkways and access ramps, which are indicative of design failure for the fabric of the Town Centre and for the user.

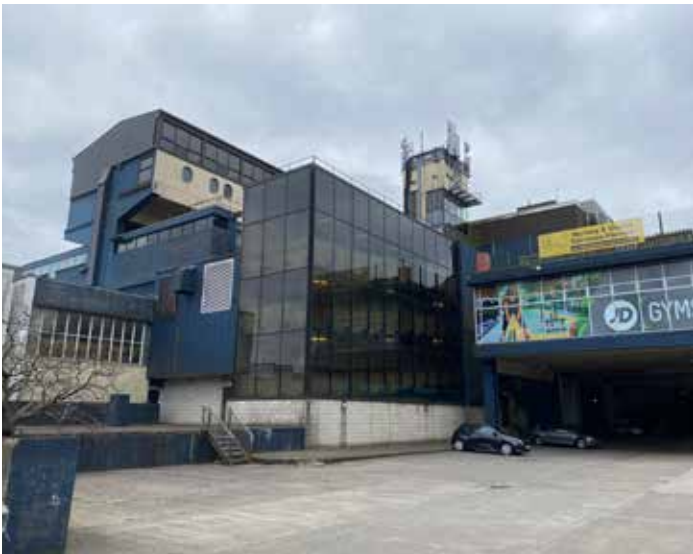
Figure 4.40 Exterior glass cladding over original Phase 1 pedestrian access ramp

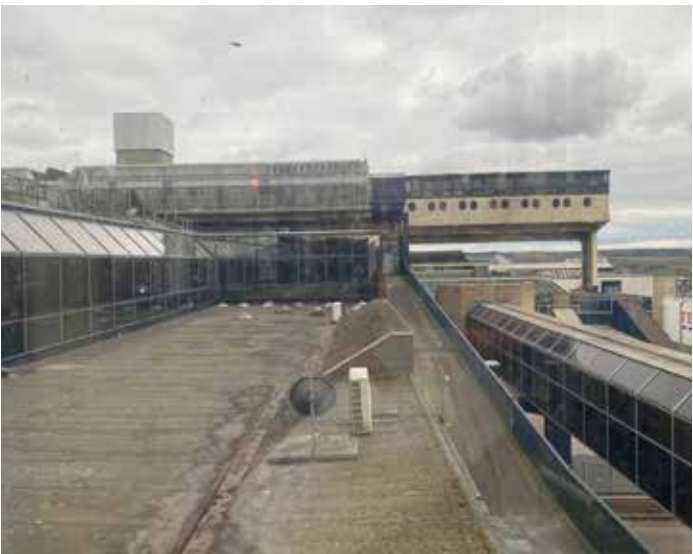
Figure 4.41 Roof above Tay Walk covered over and glass cladded, as well as encased walkway and closed off ramp

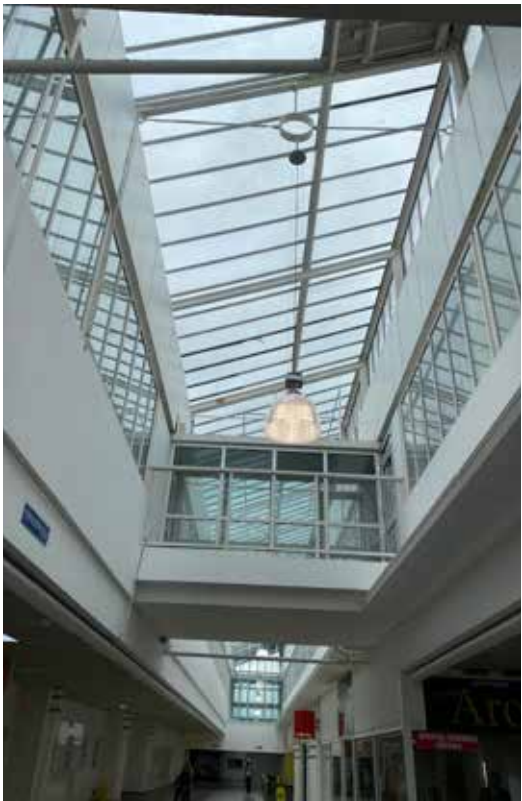
Figure 4.45 Tweed Walk covered over by glass roof

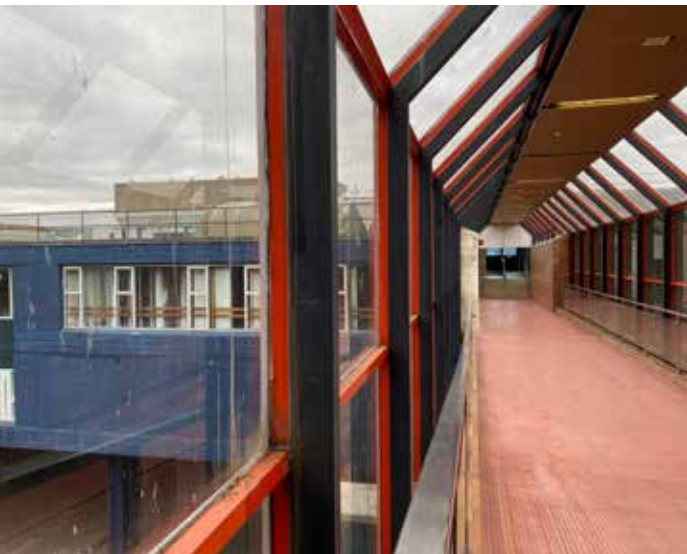
Figure 4.42 Enclosed walkway from Phase 1 to 2 over Central Way

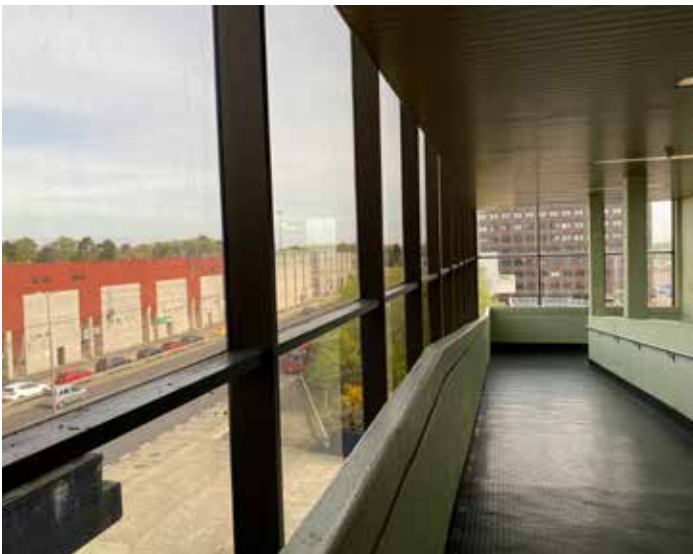
Figure 4.43 Interior view of pedestrian access ramp shown externally in 4.29 this would have been open to the elements originally

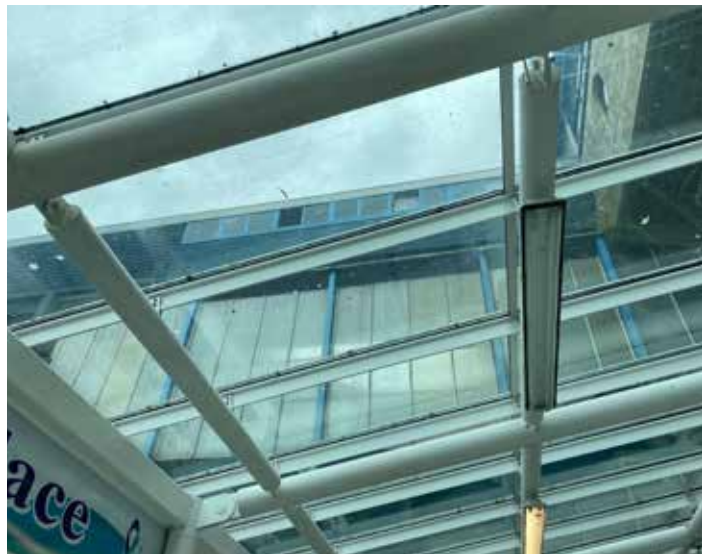
Figure 4.44 Forth Walk underneath Avon House covered over with glass roof

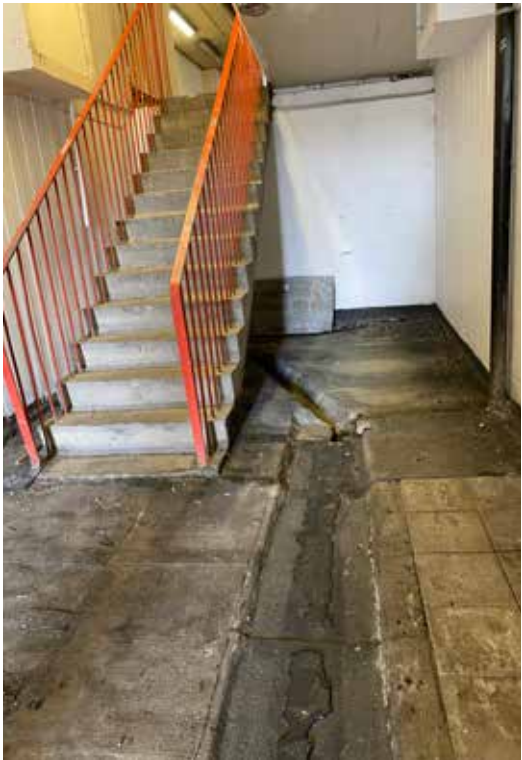
Figure 4.46 Stairwell leading down to car park level under Phase 1 showing defunct drainage channel

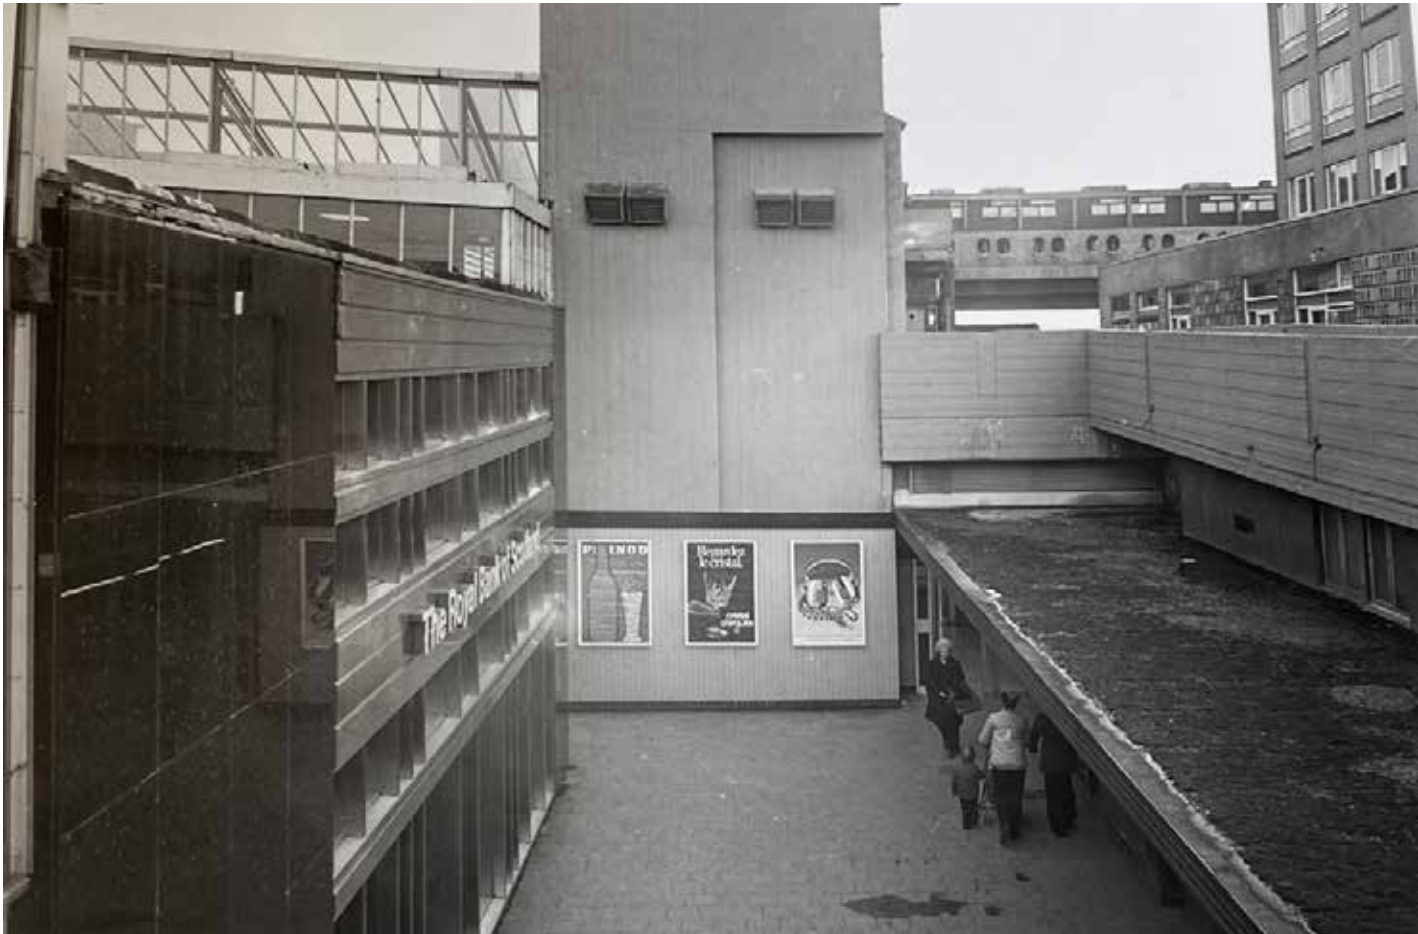
Figure 4.47 Photo of Tay Walk as originally intended, open to the elements C1970

4.82 The image above shows the original intention of open Streets in Phase 2. The Royal Bank of Scotland building is clearly recognisable with Avon House set behind. Early on in the Town Centre's operation, it was realised that the openness led to issues with water ingress into the structure, which caused not maintenance issues and slippery surfaces.

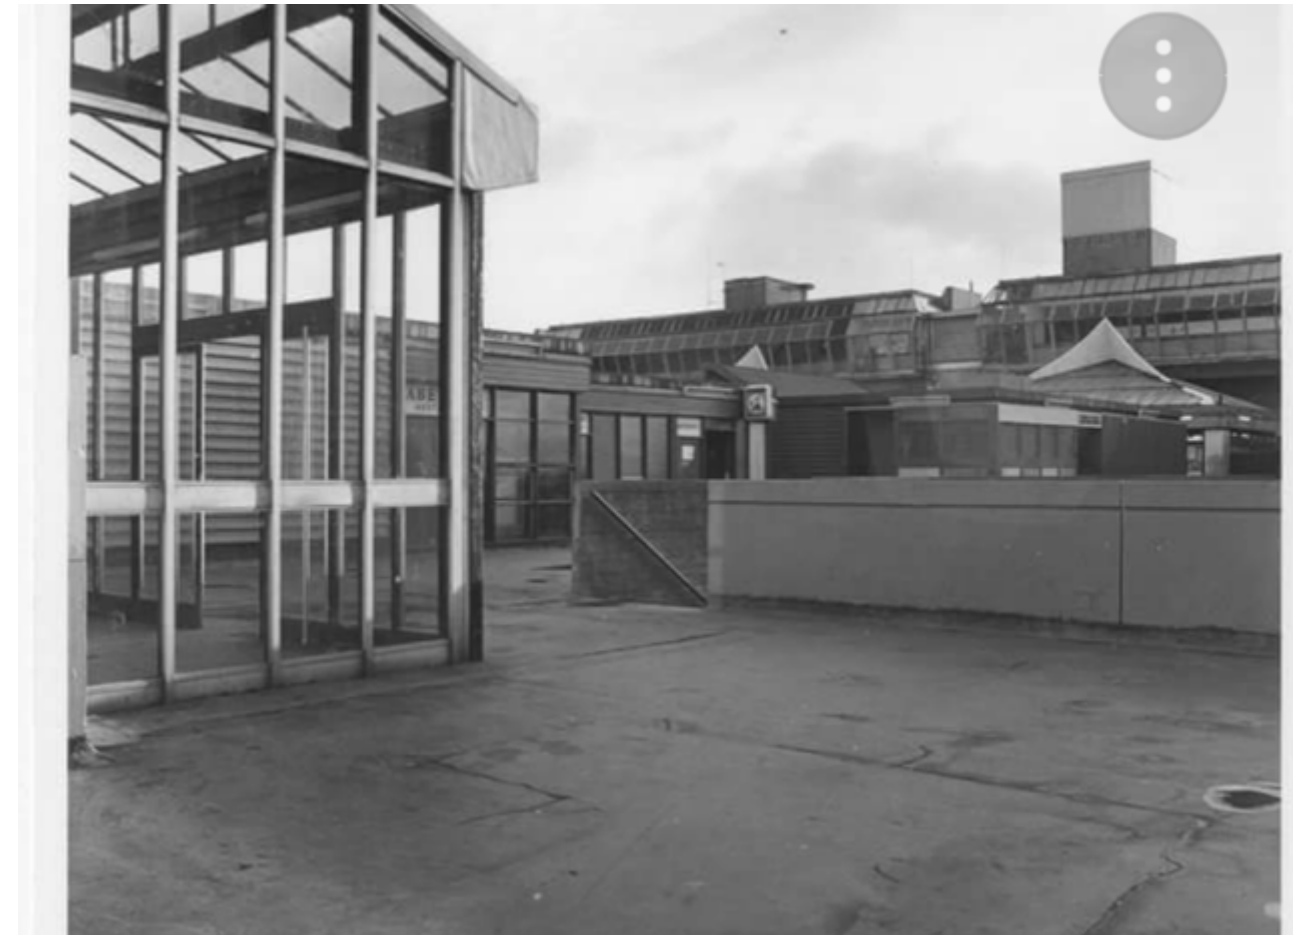
Figure 4.50 The roofscape of Phase 2 c. 1970. Note how much has since been boxed-in

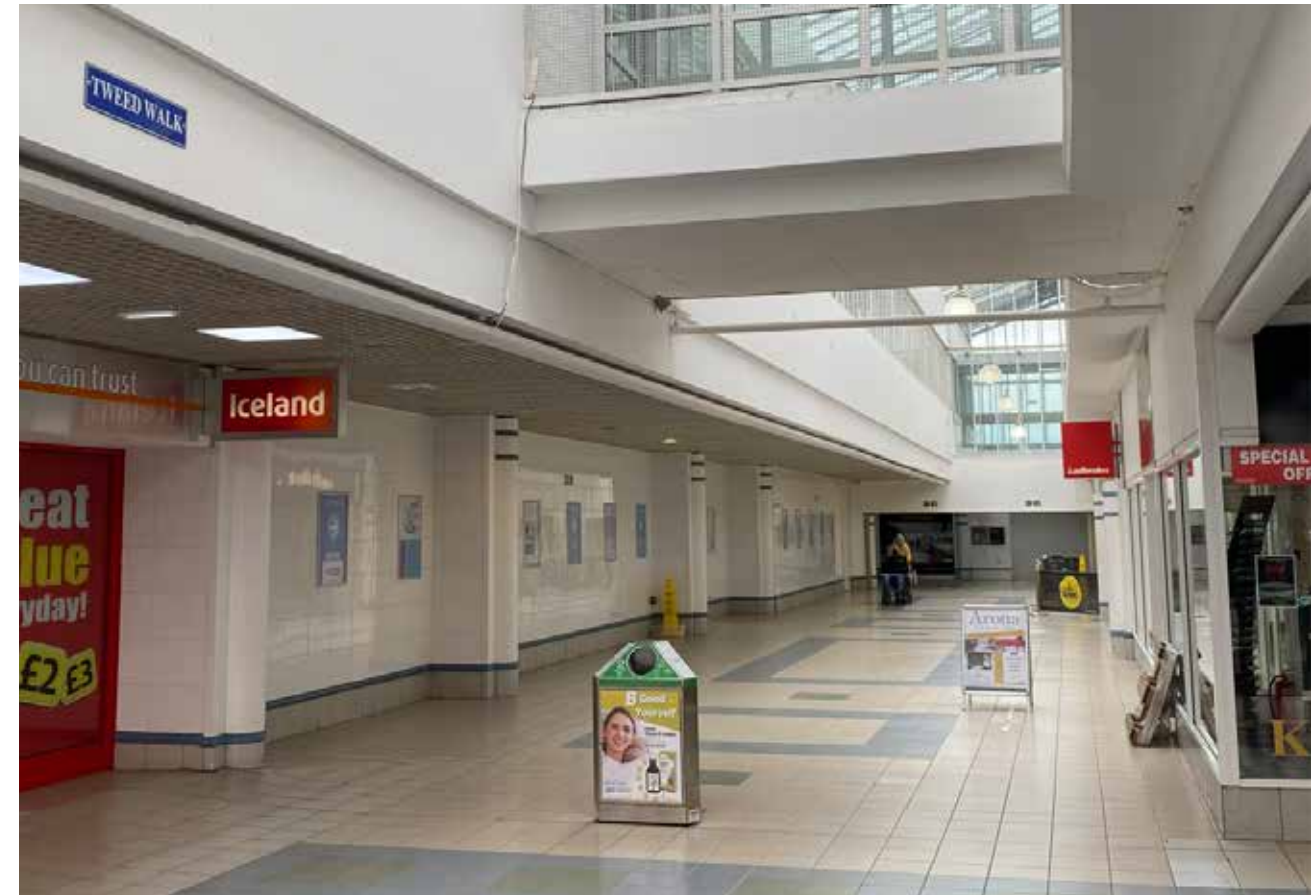
Figure 4.52 A similar view of Tweed Walk as it exists today. Note the difference in tiling, the covered walkway and blocked-up shopfronts

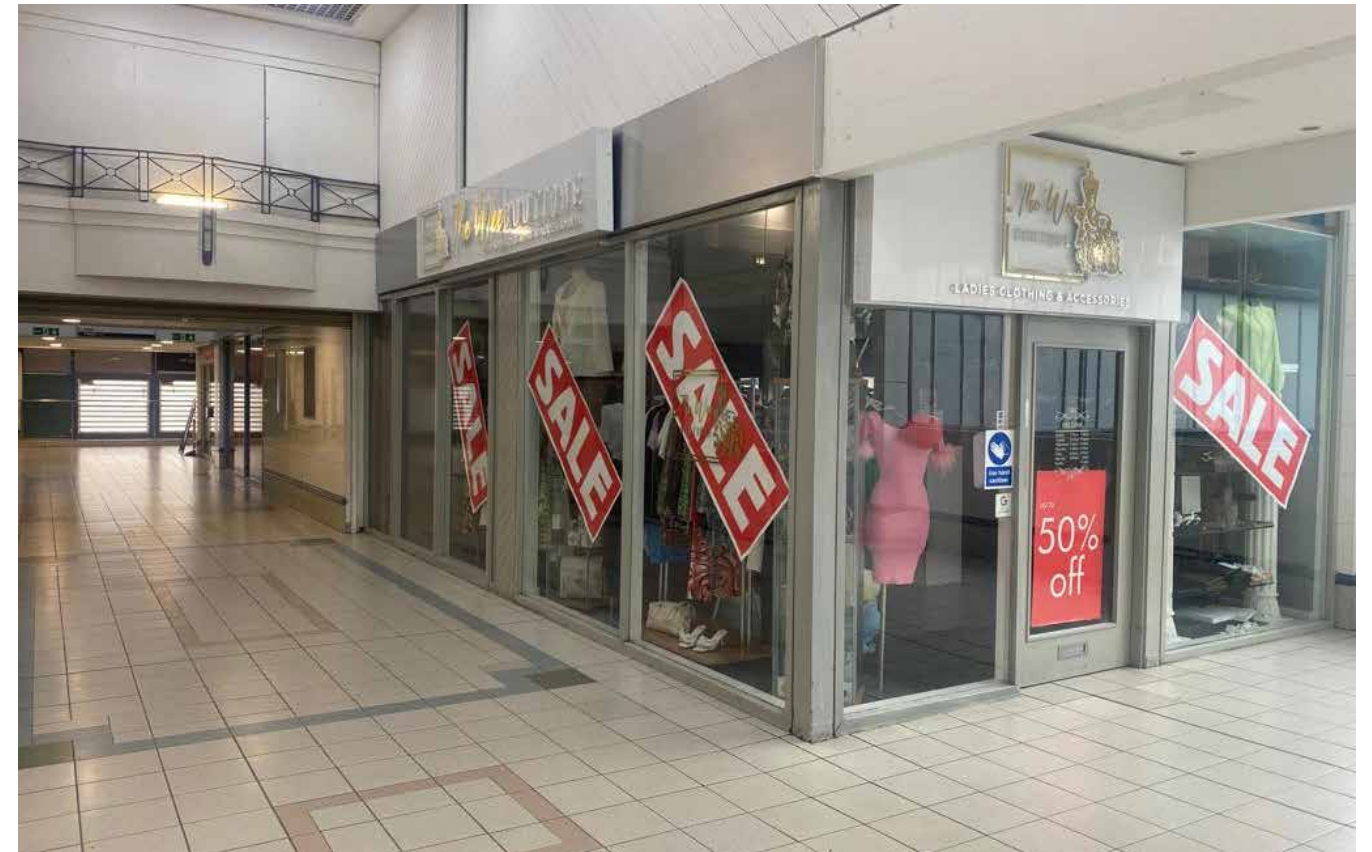
Figure 4.54 Spey walk as it exists today. This perhaps illustrates the most significant changes that occurred in this part of the Town Centre.

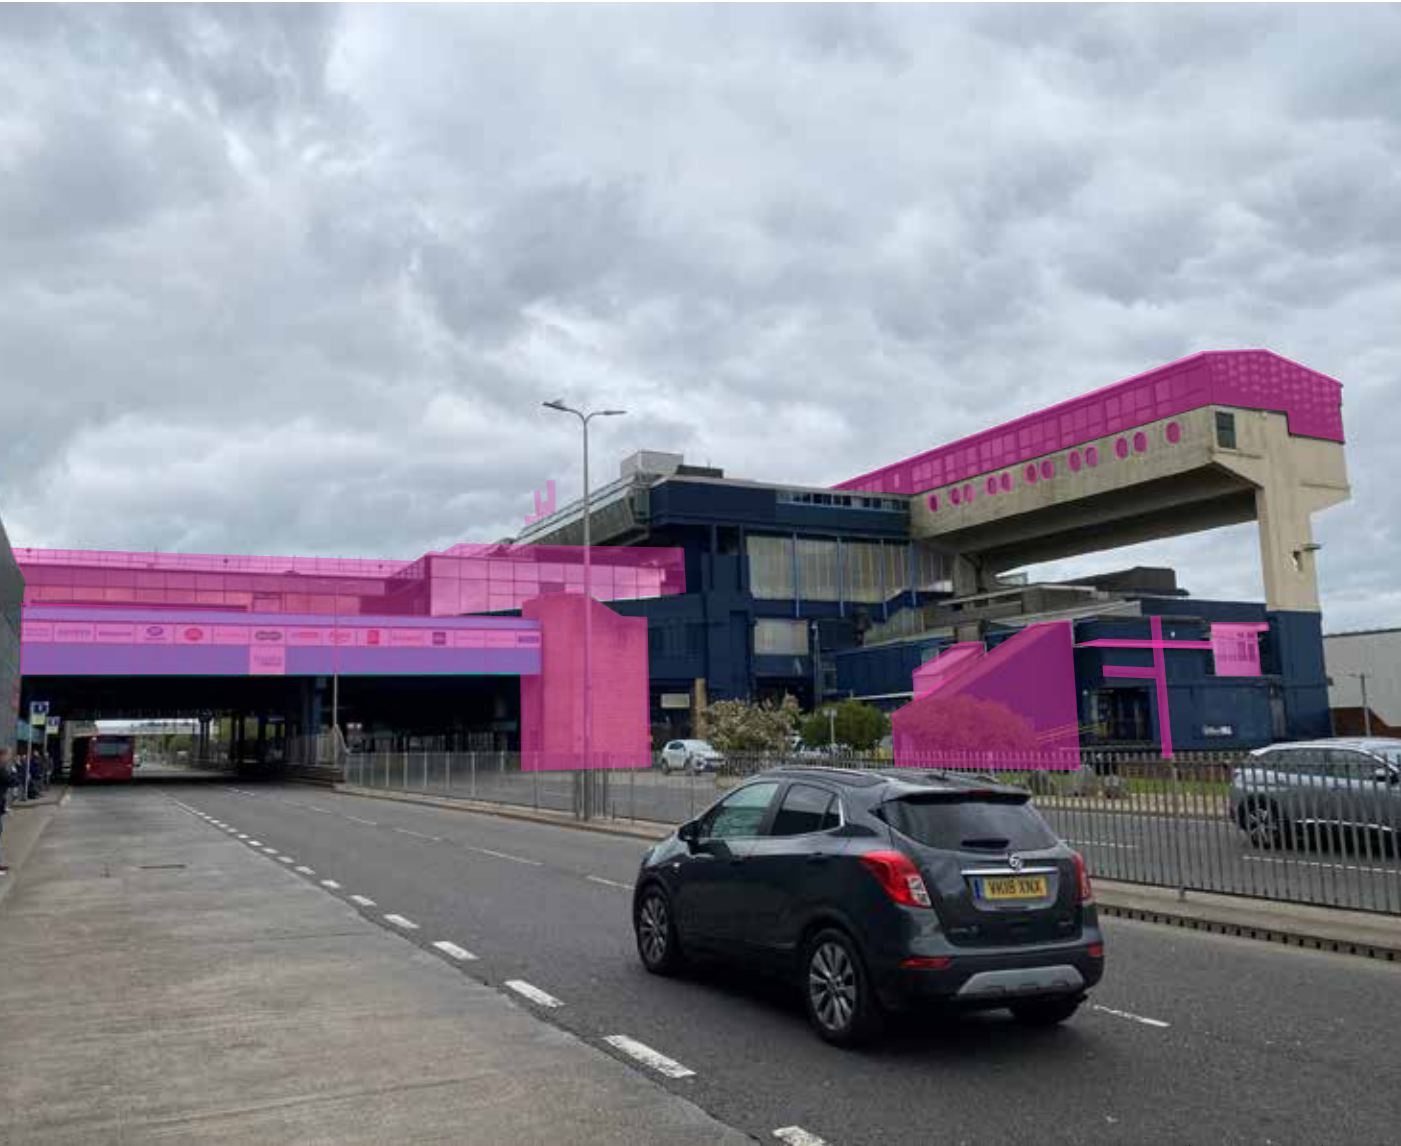
Figure 4.55 Marked up photo of non-original fabric (west elevation) Phase 1

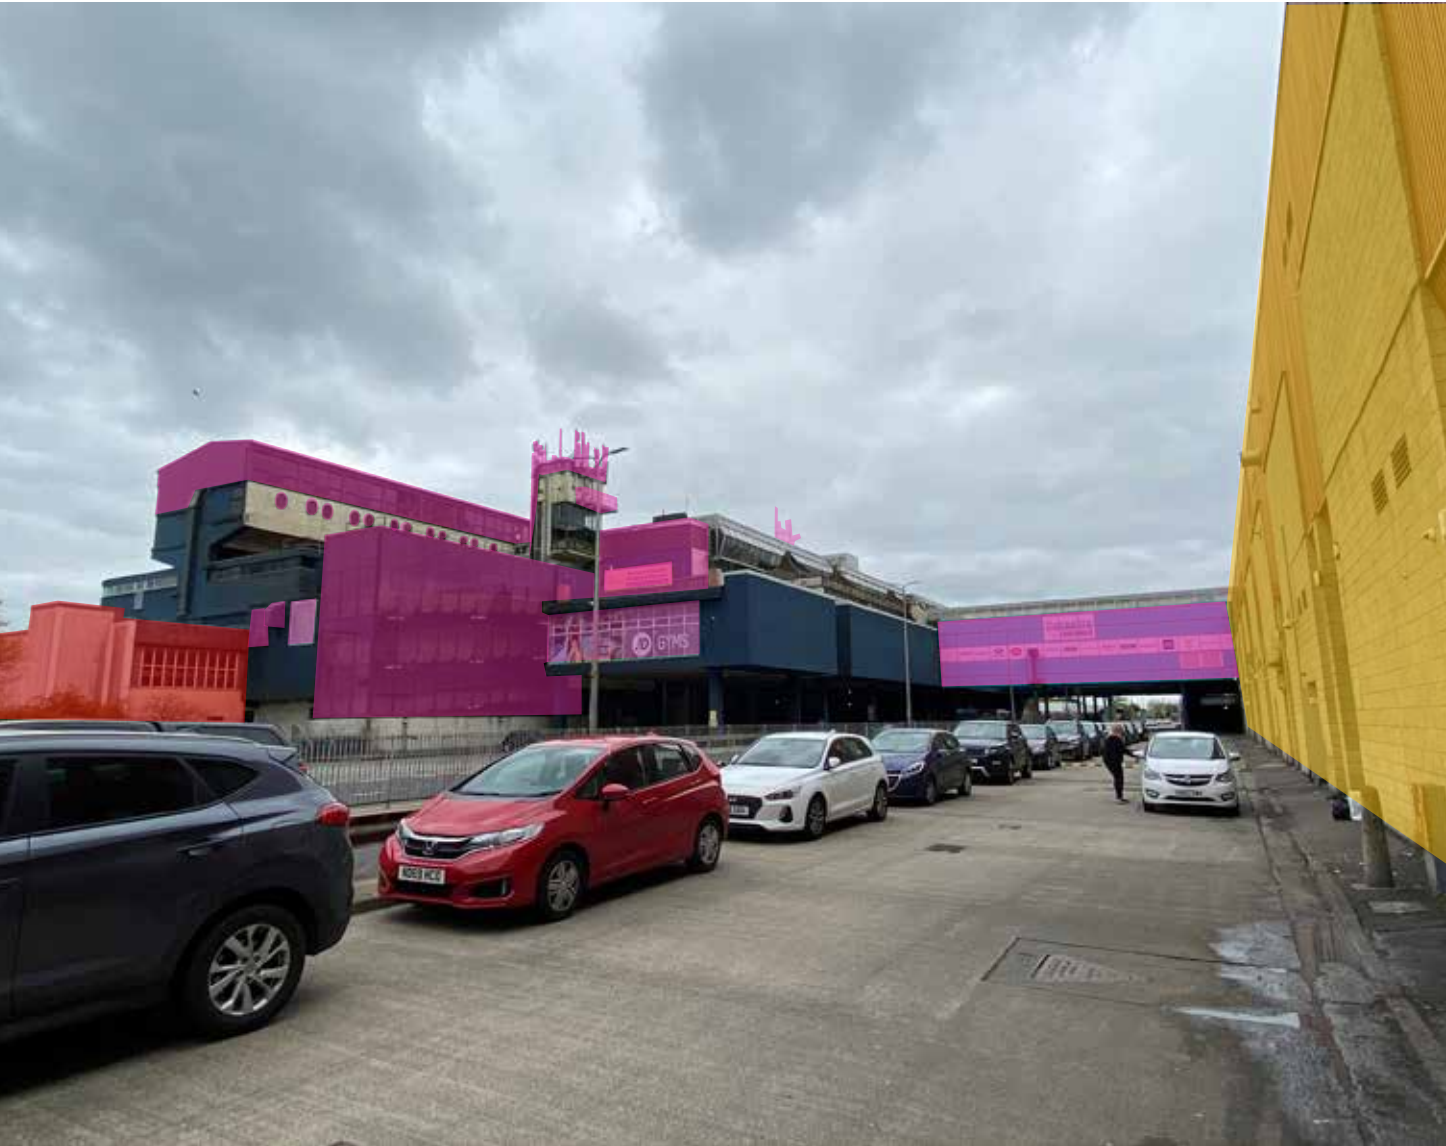
Figure 4.56 Marked up photo of non-original fabric on Phase 1 (east elevation) as well as Phase 3 & 4.
